## MARINE BORERS AND THEIR RELATION TO MARINE CONSTRUCTION ON THE PACIFIC COAST

FINAL REPORT

SAN FRANCISCO BAY MARINE PILING COMMITTEE

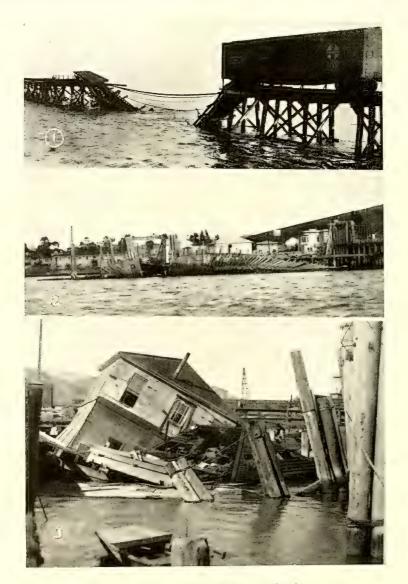
Fig. 1. Dock failures in Carquinez Strait.

(1) One of the first docks which failed. Oleum, California, Oct. 8th, 1919. Several loaded freight cars were plunged into the bay.

(2) Ferry slip at South Vallejo, failed November 4th, 1920.

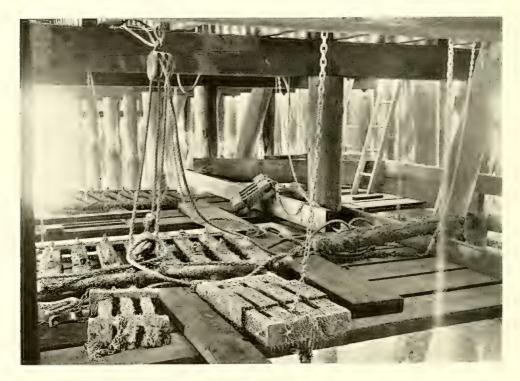
Fig. 3. Test station A at Oakland Mole, showing the high tide level platform underneath the wharf, with several test gates pulled up for inspection.

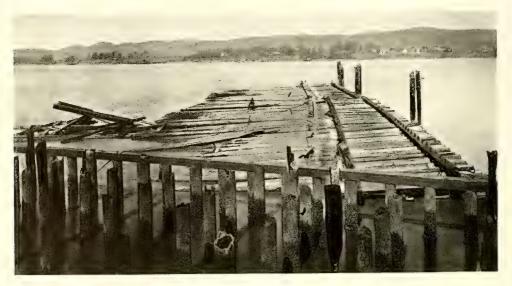
Fig. 12. Untreated ferry slip fender piles in Carquinez Strait destroyed by teredo, 1919.

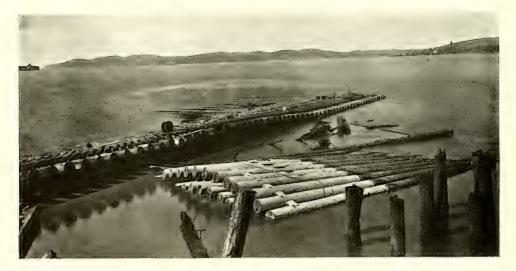
Fig. 14. Untreated ferry slip fender piles in Carquinez Strait, destroyed by *Teredo* in 1919.

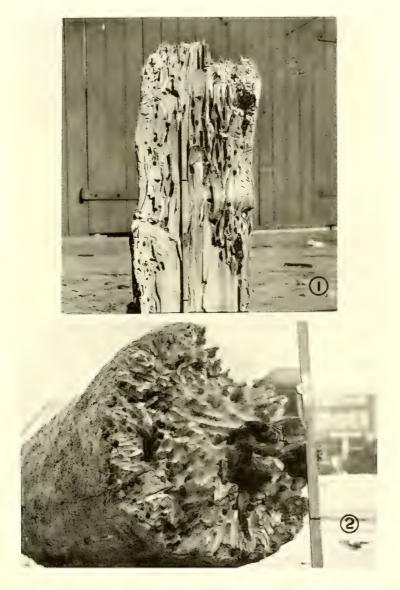
Fig. 31. (1) Untreated Douglas fir pile from Oakland Municipal Quay, east of Grove Street sewer, driven 1913, removed October, 1920. Destroyed at mud line by Bankia, surface eroded by Limnoria.

(2) The same, end view.

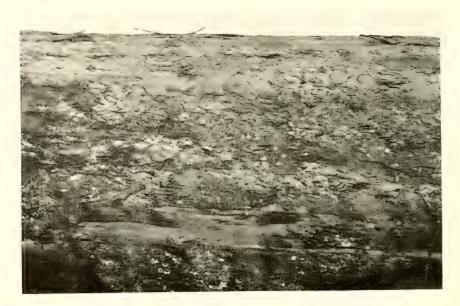
Fig. 33. Redwood pile from Fort Mason, attacked by Linmoria.

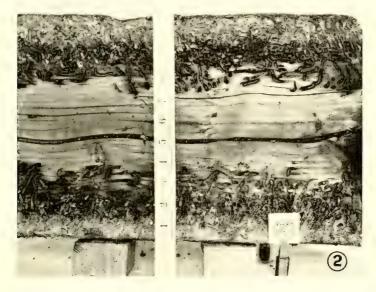
Fig. 35. Green Douglas fir pile driven at Mooring Z, Mare Island, on August 14, 1920, and pulled December, 1920. *Teredo navalis* had penetrated four inches in this four-month interval. (U. S. Navy Photo.)

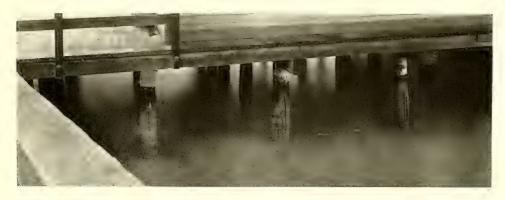
In 1921 the Southern Pacific Company drove 107 piles protected by this process in the Georgia Street wharf at Vallejo, for experimental purposes. These piles were all in actual service under ideal conditions for their use. In about 3 years the battens began swelling away from the pile and borer attack started. The piles are still in service (1925), the borer action being retarded by the surface protection, but it does not appear likely that a life exceeding about 5 years will be secured.

Fig. 38. Bulging battens on piling protected by Moran and Paraffine processes at Georgia St. wharf, Vallejo, after three years' service. (S. P. Co. Photo.)

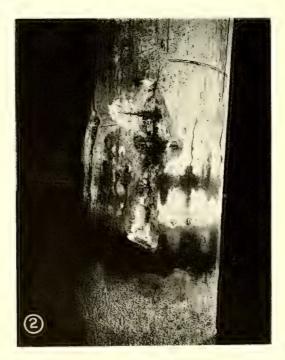
When the casings are made and placed with sufficient care, including adequate bottom penetration of the concrete shell to insure that the wooden pile will not be exposed by subsequent dredging or scour, good protection can be obtained. Their durability is then affected by the factors which ordinarily influence the life of good concrete in sea water. There is some danger of developing cracks during handling,

Fig. 48. Concrete jacketed pile, pre-cast type, showing typical rusting crack above high tide level. From bulkhead between Piers 28 and 30, San Francisco; driven 1909.

which would admit sea water to the reinforcement and permit rust to form, but this can be prevented by proper care in the handling. The cost is relatively high and a long life is therefore necessary to justify it.

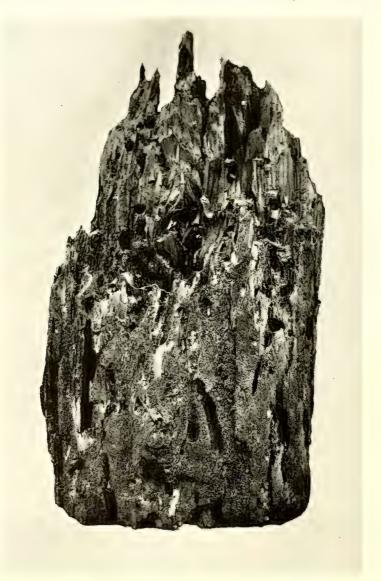
Fig. 55. Untreated Douglas fir pile from 16-pile dolphin at Southern Pacific Alameda Mole, driven February, 1919. Removed November, 1920, on account of destruction at mud line by *Bankia*, *Limnoria* and *Teredo*.

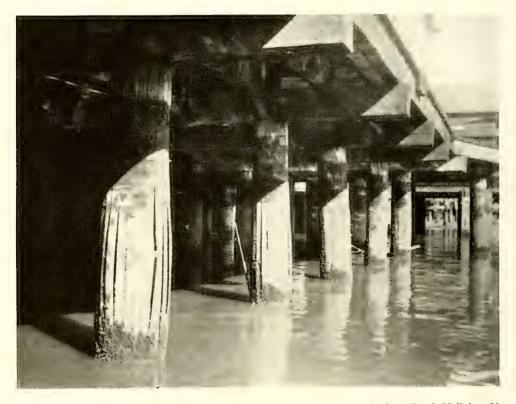
Fig. 56. Piling treated by Moran process, exposed 2 years at Georgia St. Wharf, Vallejo. Note bulging and broken battens. (S. P. Co. Photo.)

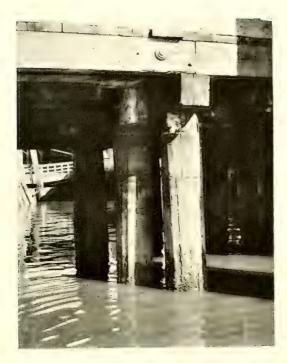
Fig. 57. Piling treated by Paraffine Paint process, exposed 2 years at Georgia St. Wharf, Vallejo. Same defects developing as in fig. 56. (S. P. Co. Photo.)

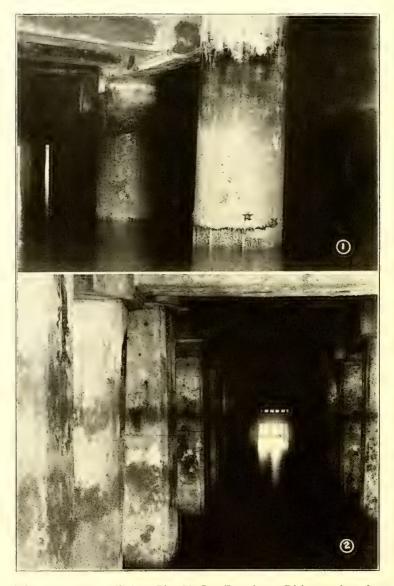
Fig. 59. (1) Reinforced concrete cylinders, Pier 28, San Francisco. Disintegration of concrete due to poor workmanship and improper tamping. These cylinders were repaired by encasing in dense concrete.
 (2) Reinforced concrete piles, Pier 35, San Francisco; 6 years exposure, excellent condition.

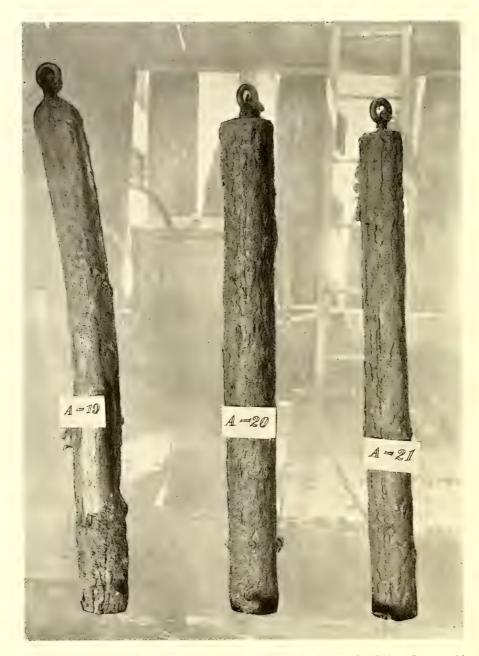
Fig. 61. Samples exposed 16½ months at the Oakland Mole. No. A19. Oregon alder considerably attacked by *Limnoria* except in areas where bark remained on. Compare area above the white card with smooth area below, where bark was removed just before photographing. No. A20. Douglas fir sample dipped once in "Elaterite." General attack by *Limnoria* all over surface. No. A21. Douglas fir sample dipped twice in "Elaterite." Heavily attacked by *Limnoria*. Diameter considerably reduced.

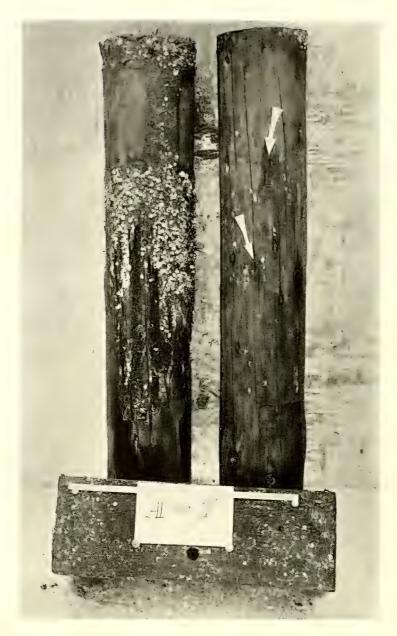
Fig. 63. Test No. A7. Douglas fir samples treated with Williams and Francois oil, photographed after 28 months' exposure. Sample at left shows heavy *Limnoria* attack. Sample at right shows initial *Limnoria* attack, as indicated by arrows. The other depressions in the surface of this sample are knots. Barnacles were scraped from this sample before photographing. Sample at bottom of photograph is a part of the creosoted frame in which the samples were held for testing; it showed no attack, the hole in the center being a bolt hole.

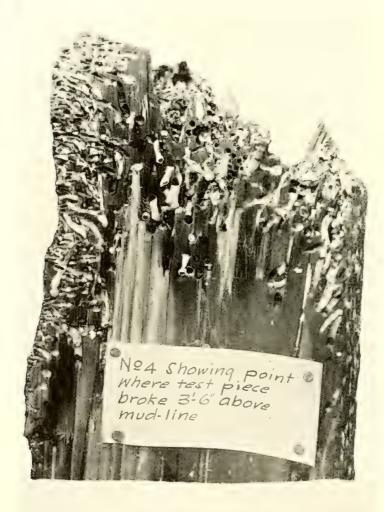
Fig. 87. Breaking point of a 6 x 8 Douglas fir timber planted at Southern Pacific wharf, Port Costa, California, July 1, 1920. First larvae detected at this locality on August 4. Timber removed December 8, 1920. Destroyed by *Teredo navalis*.

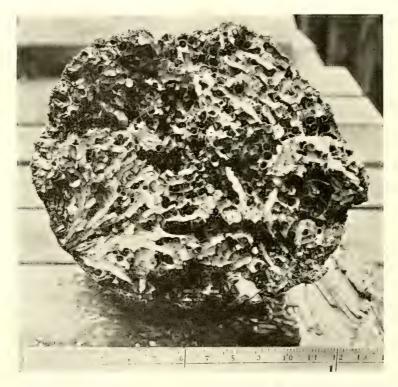
stance of even more rapid destruction is furnished by piling driven in a pipe line to a dredge near the Southern Pacific Oakland Mole on or about May 22, 1923, and removed October 22. Some of these piles were entirely destroyed at the mud line by *Bankia*, as illustrated in figs. 89 and 90. This destruction had accordingly occurred in 5 months or possibly less. The piling, being already watersoaked, was doubtless attacked soon after the driving.

Fig. 89. Breaking point, near mud line, of pile at Oakland Mole, destroyed within 5 months by Bankia setacea.

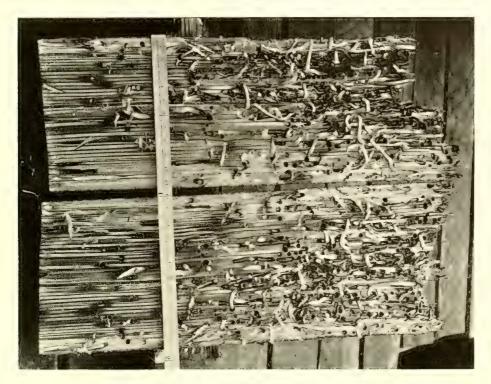
Fig. 90. Split section of pile shown in fig. 89.

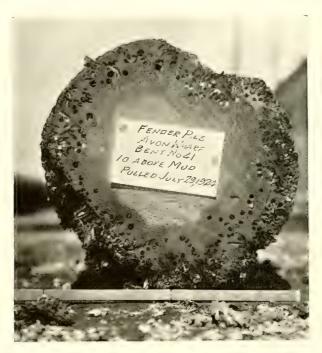
The autumn of 1923 was marked by a recurrence of conditions of increased salinity in the upper bay, and a renewed extension of the activities of *Teredo* in this region. On November 28th specimens 4 cm. or more in length were found in test timbers at the wharf of the Associated Oil Company at Avon, and there is evidence that some individuals established themselves during this season as far up as Pittsburg. No surviving specimens were found at the latter locality when a search for them was made on June 23, 1923, indicating that the limit of survival during the winter of 1922-1923 was at some point between Avon and Pittsburg. At Avon some specimens had reached a length of 7 cm. by June 1st, and appeared to be in healthy condition at that time. By the end of July it was found that they had seriously damaged the piling at this locality, as shown in figure 96.

Fig. 96. Section of untreated fender pile from Avon wharf of Associated Oil Co. Pulled July 29, 1924.

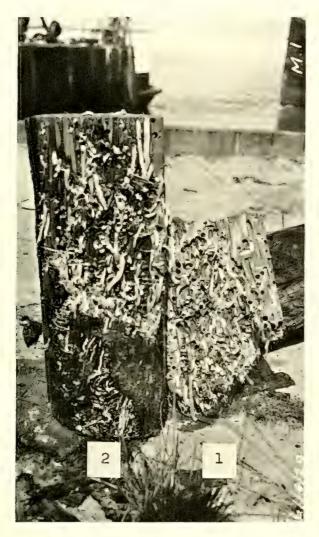
Fig. 116. Pile from Seattle, driven December, 1922, pulled June, 1924. Entirely destroyed at mud line by *Bankia setacea*.

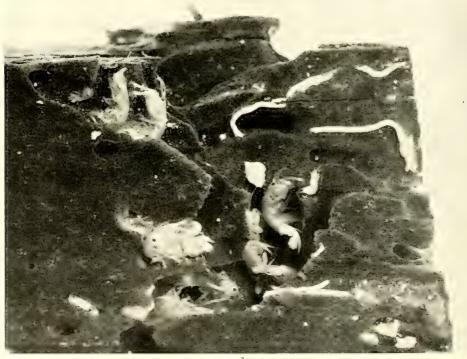
Fig. 136. (1) Portion of a  $3\frac{1}{2}$ " x  $3\frac{1}{2}$ " x 6" test block submerged eight months at Tutuila, showing damage by *Limnoria andrewsi* and *Chelura insulae*. The ends of a few *Teredo* burrows have been exposed.  $\times$   $\frac{3}{4}$ .

- (2) All that remained of a 2" x 3½" x 5" test block submerged eight months in Honolulu Harbor. The major damage was occasioned by Limnoria andrewsi; Limnoria lignorum and Chelura insulae were also present in the block. All Teredo were dead as a result of exposure of their burrows by the crustacean borers. × ¾.
- (3) Portion of block from Tutuila, showing *Chelura insulae* in place in burrows. One *Limnoria andrewsi* is seen in place near lower left corner.  $\times$  5.

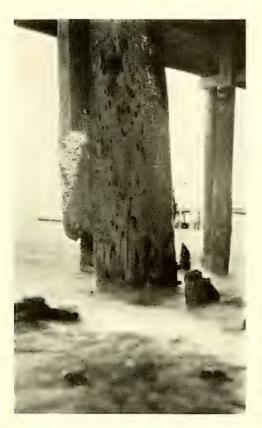
Fig. 139. Pile at China Camp, on the west shore of San Pablo Bay, attacked by Sphaeroma pentodon between tide levels.
